Evaluation of Bridge Rail Cracking – N. Ohio St. Overpass Salina Kansas

Report to
City of Salina, KS
300 W. Ash
P.O. Box 736
Salina KS 67402

October 2, 2007

CTLGroup Project No. 210706

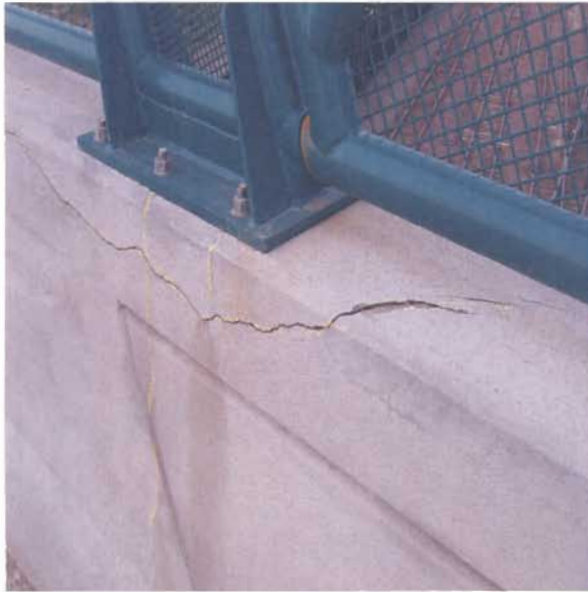
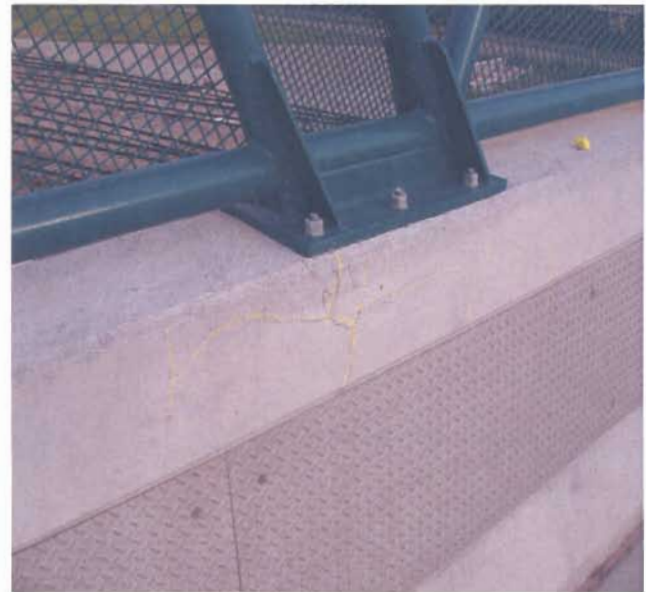
A comprehensive visual inspection was performed of the west parapet. Rail cracking was mapped at 71 anchorage locations on the roadway face of the parapet, and at 62 locations on the outside face of the rail. A total of 22 anchorage locations were noted to exhibit horizontal cracking below the anchorage zone, see Figs. 1 and 2. The crack widths varied from 0.005 in. to 0.25 in. A cover meter was used to evaluate the depth of the anchor bolts at a random sample of anchorage locations. Depth of the u-bolt embedment into the parapet was estimated to range from 4 in. to 5 ½ in.

Figs. 1 and 2 – Parapet Cracking at Roadway Fence Anchorage

Based on our field evaluation, review of design documents, and computer modeling and analysis, we attribute the horizontal cracking around the anchorages of the concrete barrier rail to overstress of the anchorage connection. The vertical intermittent cracking of the barrier rail is attributed to restrained shrinkage of the parapet. The anchorage is determined to be overstressed under two conditions, tension pull-out of the bolts, and combined shear-tension interaction. The concrete failure was likely caused principally by design factors:

- The fence anchorage design did not account for thermal forces transferred to the parapet from the fence system. The geometry, stiffness, indeterminacy, and restraint inherent in the unique fence architecture introduced significant additional loads on the connection and the parapet, which were not considered in design.

- In determining capacity of the anchorage system, original design calculations did not consider all of the possible loading conditions and failure modes; particularly group failure and interaction of combined tension and shear.

- The u-bolts were assumed to behave as headed studs in calculating anchor pull-out capacity. At the date the design calculations were completed, the PCI Design handbook 5th Edition and ACI Building Code Requirements for Structural Concrete 2002 were available. Both of these references contain design equations for calculating capacity of hooked bolts which more closely approximates the actual condition.

Cracking on the west rail indicates an overload condition in the anchors. This overload most likely has reduced the strength of the connections. Precautions should be taken to temporarily brace the west rail fence attachments where horizontal cracking is occurring to assure safety of the west side attachment under lateral loading. Because the concrete has experienced significant cracking in many locations, retrofit of the anchorage may not be possible and replacement of the damaged concrete may be necessary. To properly anchor the fence system to the bridge superstructure without causing a failure of the concrete parapet, one of the following should be provided 1) the anchorage should be re-designed with enough capacity to resist all loads transferred from the fence system, or 2) the connection should be detailed to accommodate the applied design forces rather than transfer them to the concrete parapet. Due to the lack of sufficient capacity of the anchorage and resulting tensile failure observed in the concrete, we do not recommend a redesign or retrofit of the anchorage and repair of the concrete without removing the fence. CTLGroup can assist the City with preparation of more detailed repair concepts and repair plans.

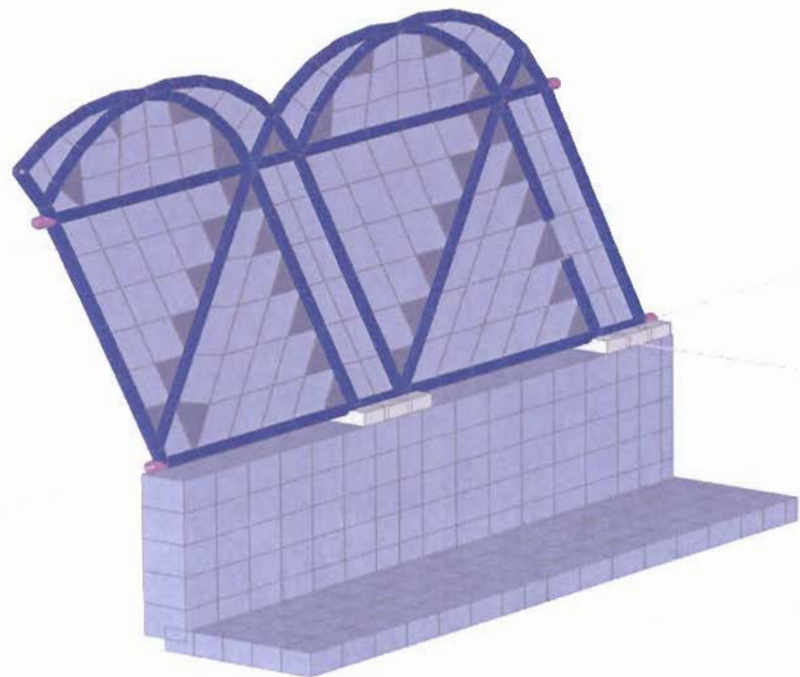
A finite element analysis of the roadway fence was created to analyze the reactions at the fence base; see Figs 3 and 4. The AASHTO Group V load combination was used for determination of the reactions at the fence base. Based on the fence installation occurring in February, a temperature gradient of 40°F was applied to the model to obtain thermal forces.

Fig. 3 – Finite Element Rendering of Pedestrian Fence Interior Unit

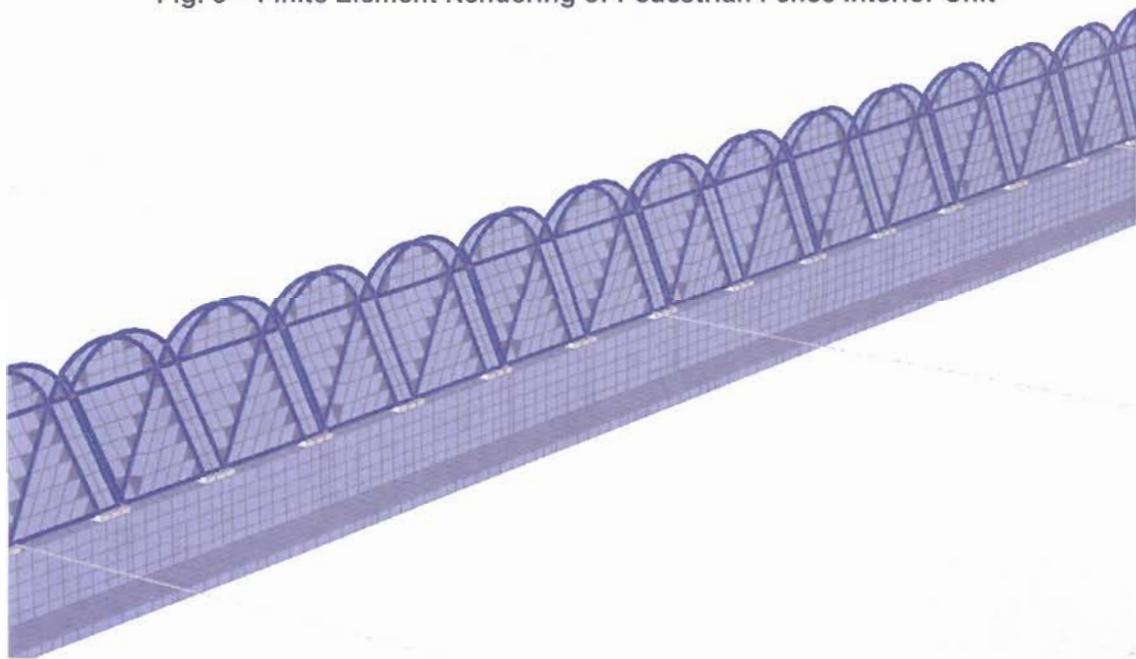
Fig. 4 – Finite Element Rendering of Pedestrian Fence
